## Spill Prevention Control and Countermeasure Inspection Findings, Alleged Violations, and Proposed Penalty Form

## SPCC - EXPEDITED FIELD ENFORCEMENT PROGRAM

SITE NAME: N all/Longview SPCC TDD#: S06-9802-008 PHOTO#: 104 dOTOGRAPHER/WITNESS: Green/Hood

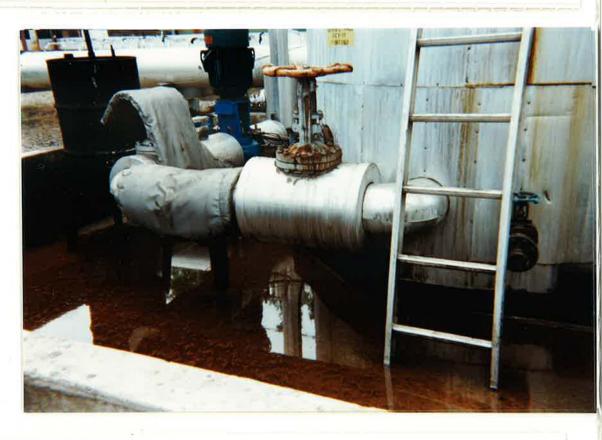
Cook Polymer heat transfer storage tank standing water in secondary

containment

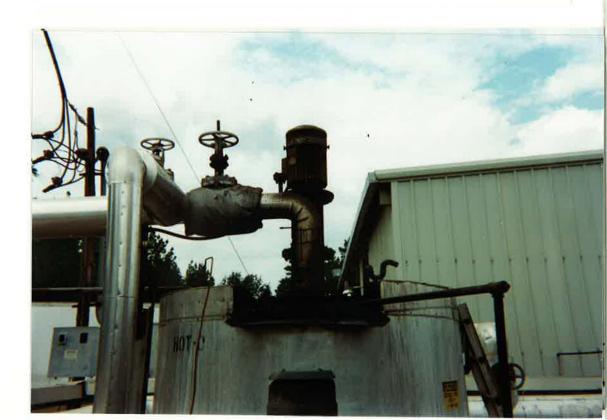
SITE NAME: Marshall/Longview SPCC TDD#: S06-9802-008 PHOTO#: 105 PHOTOGRAPHER/WITNESS: Green/Hood

staining from product on top of tank
